Re: Compliance Evaluation Inspections  
Concrete Supply Company, Lincolnton, NC  
NPDES Permit No. NCG140046

## Water Compliance Inspection Report

Concrete Supply Company - Lincolnton Plant

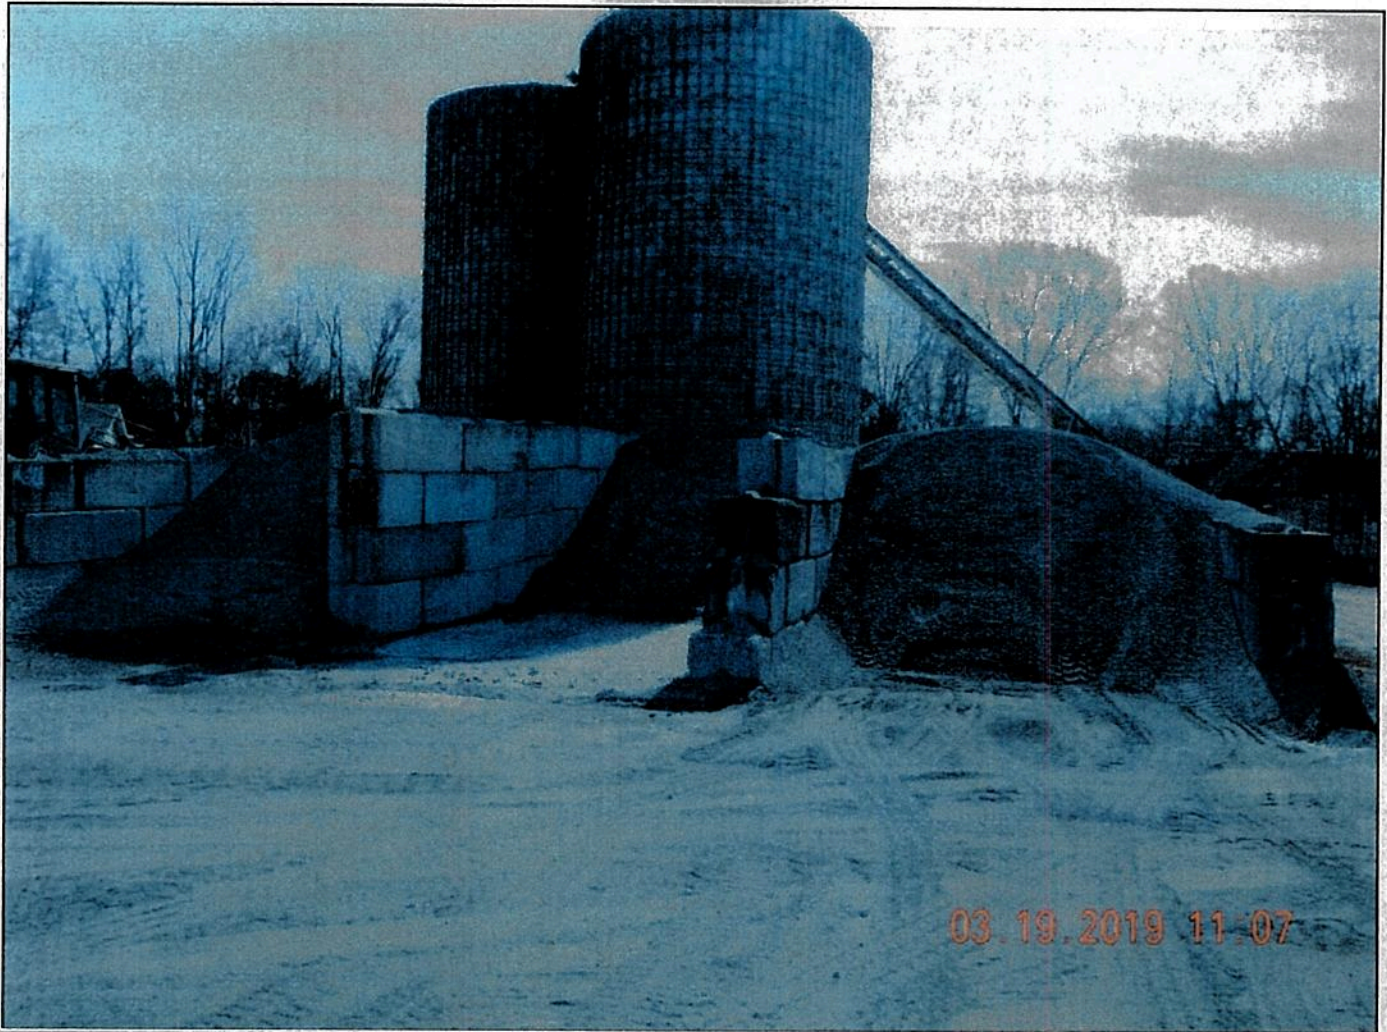
File Name	DSCN1853.JPG
Description	Photograph of the outdoor material storage piles.
Latitude	N 35° 27' 36.50"
Longitude	W 81° 15' 36.70"

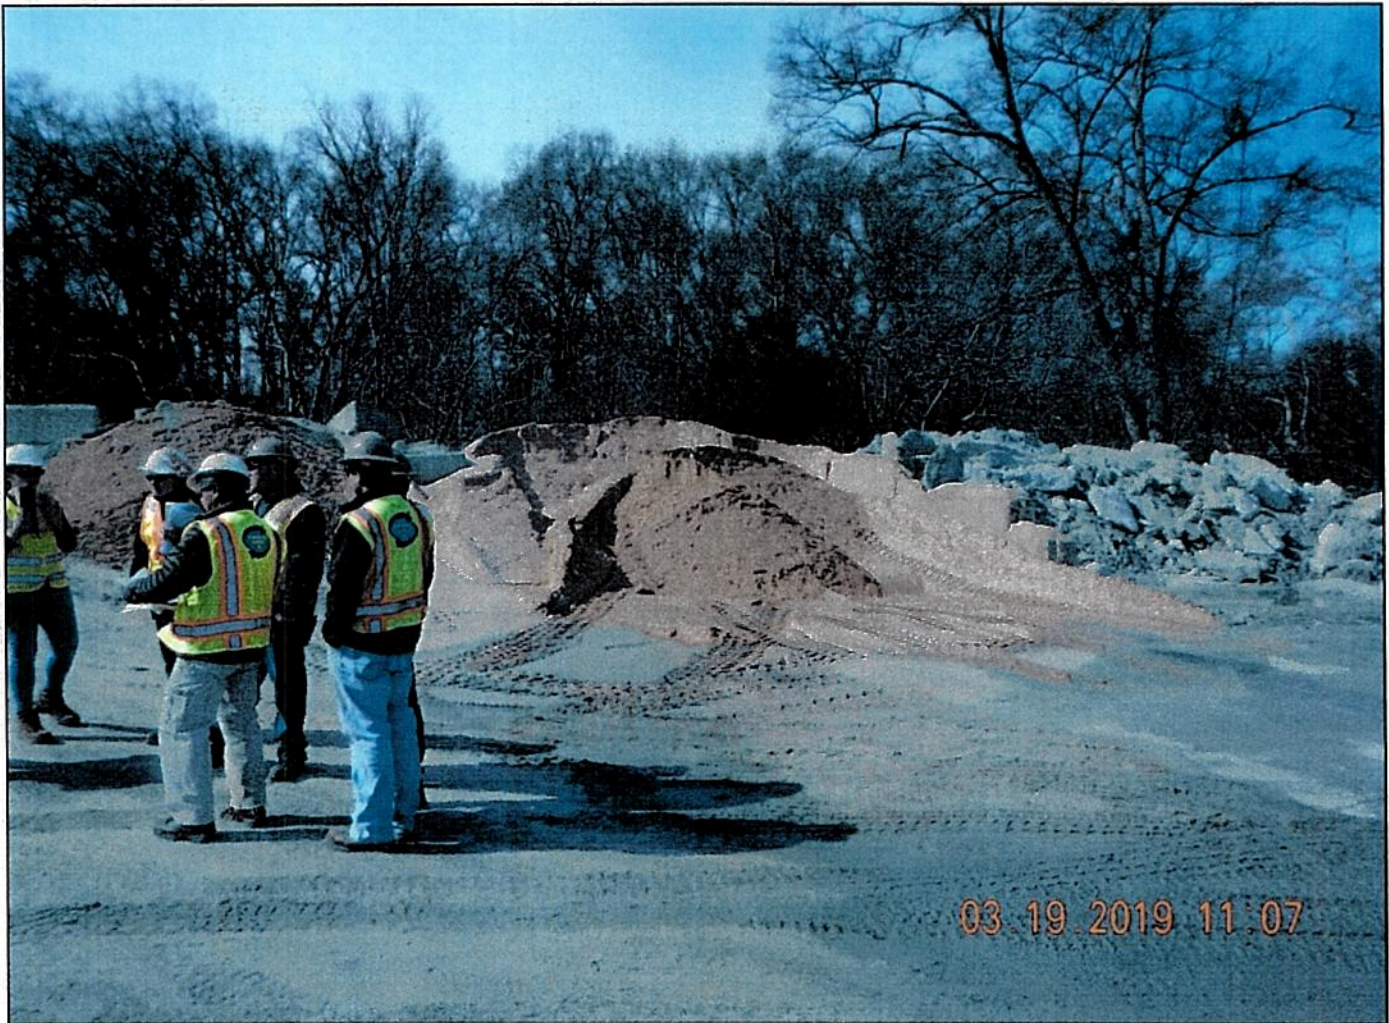
File Name	DSCN1854.JPG
Description	Photograph of the material storage piles. Some sediment tracking was observed from the sand storage pile. A concrete waste storage area can be seen in the back of the photograph along the south side of the property.
Latitude	N 35° 27' 36.51"
Longitude	W 81° 15' 36.76"

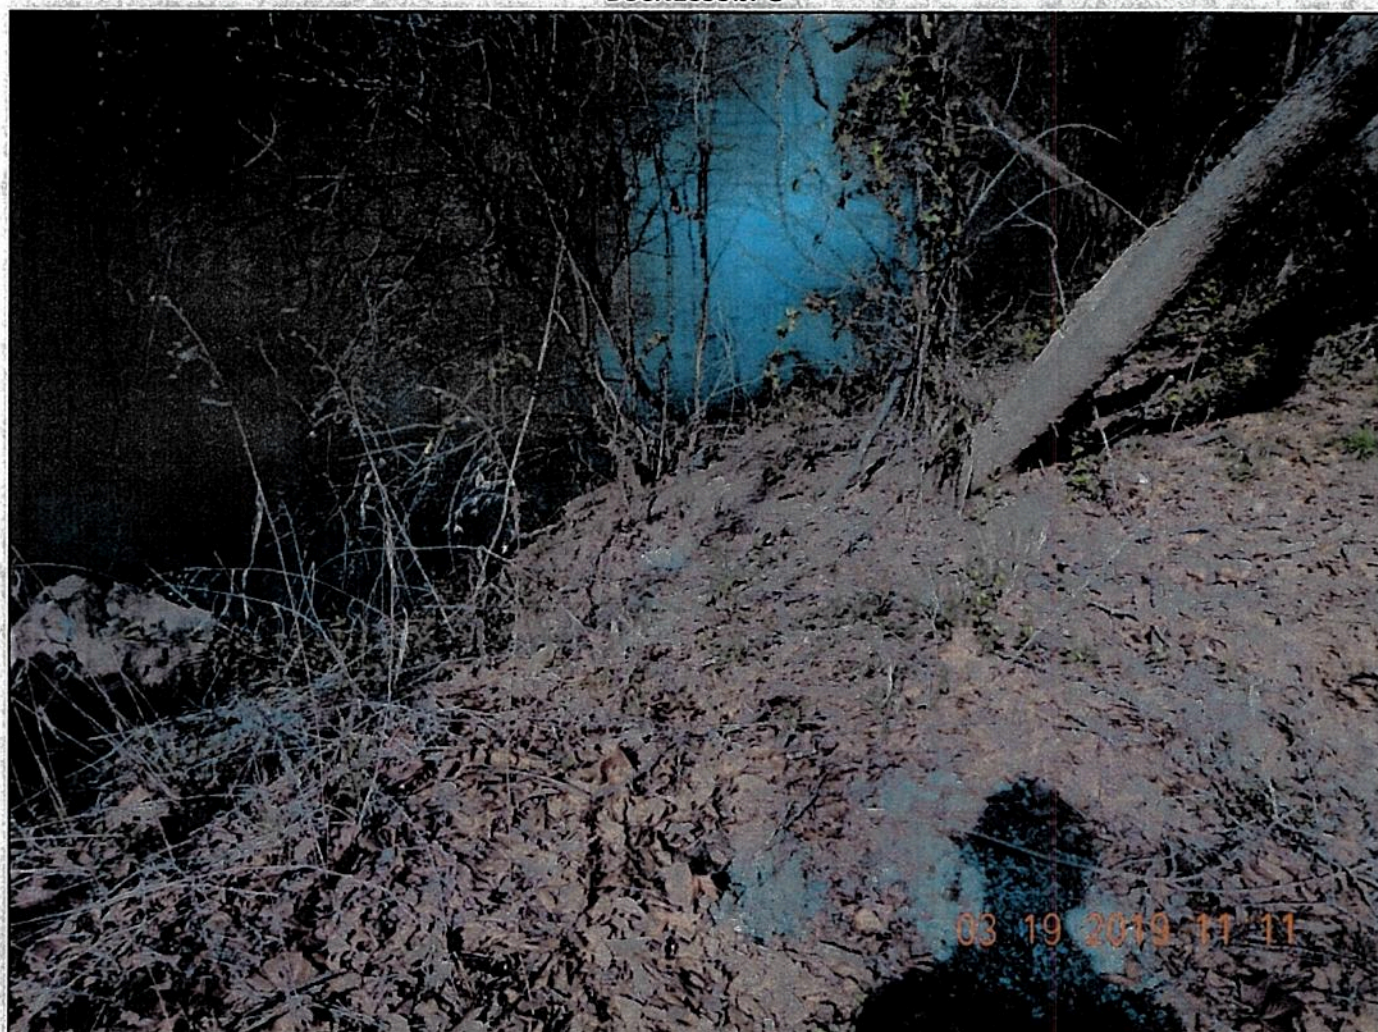
File Name	DSCN1855.JPG
Description	Junction point with the stream and the old outfall from the site which was considered closed out and removed from its permit requirements.
Latitude	N 35° 27' 34.22"
Longitude	W 81° 15' 34.22"

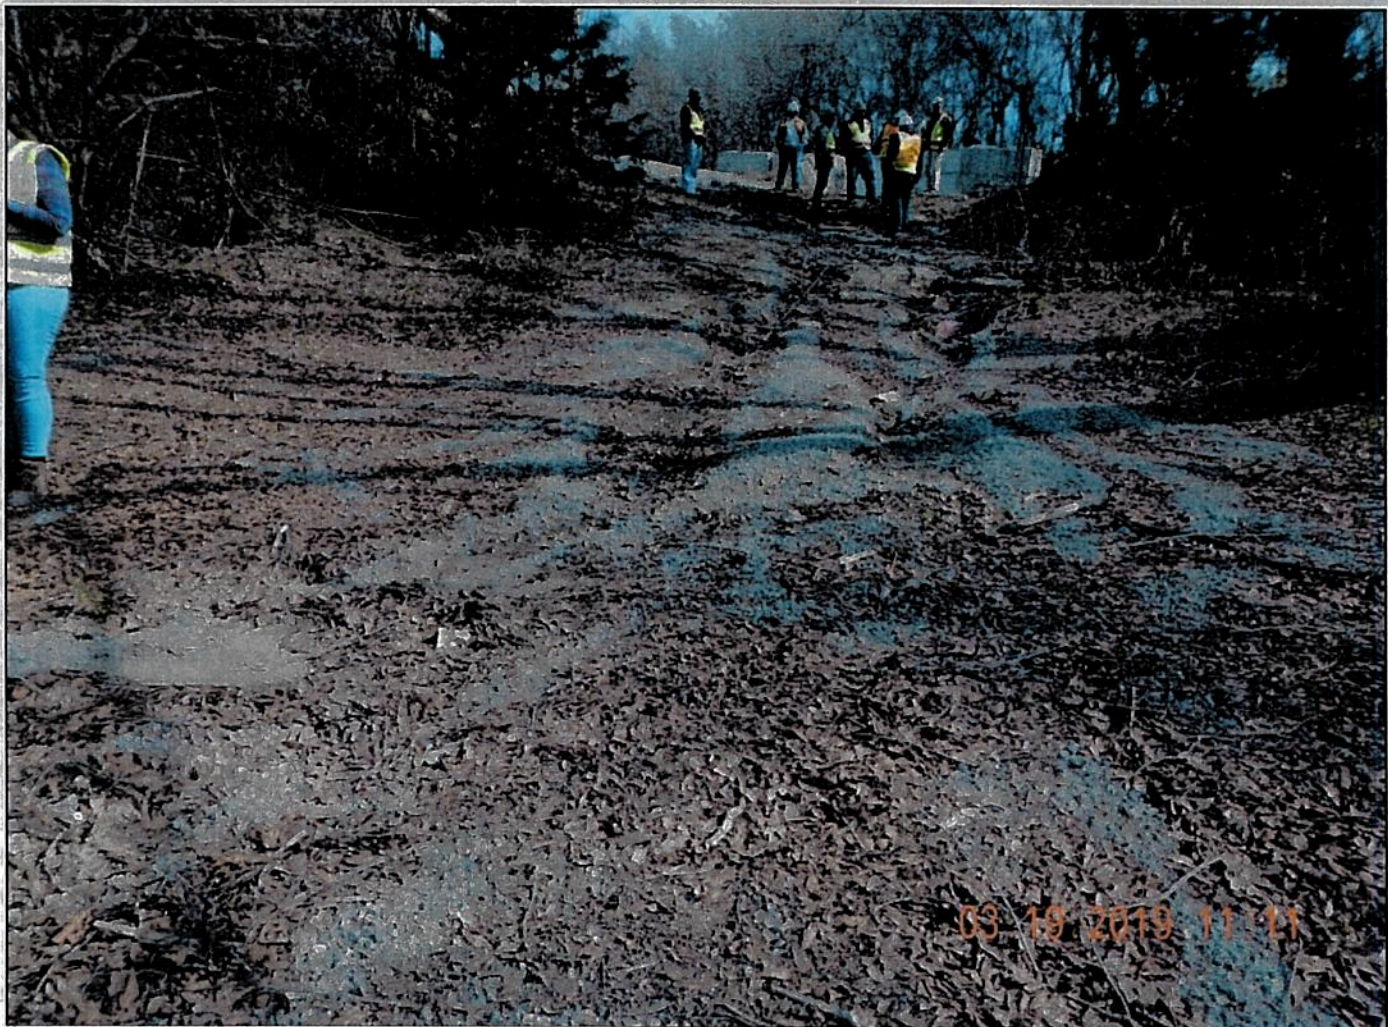
File Name	DSCN1856.JPG
Description	Down gradient from the former outfall leading to the stream.
Latitude	N 35° 27' 34.40"
Longitude	W 81° 15' 34.91"

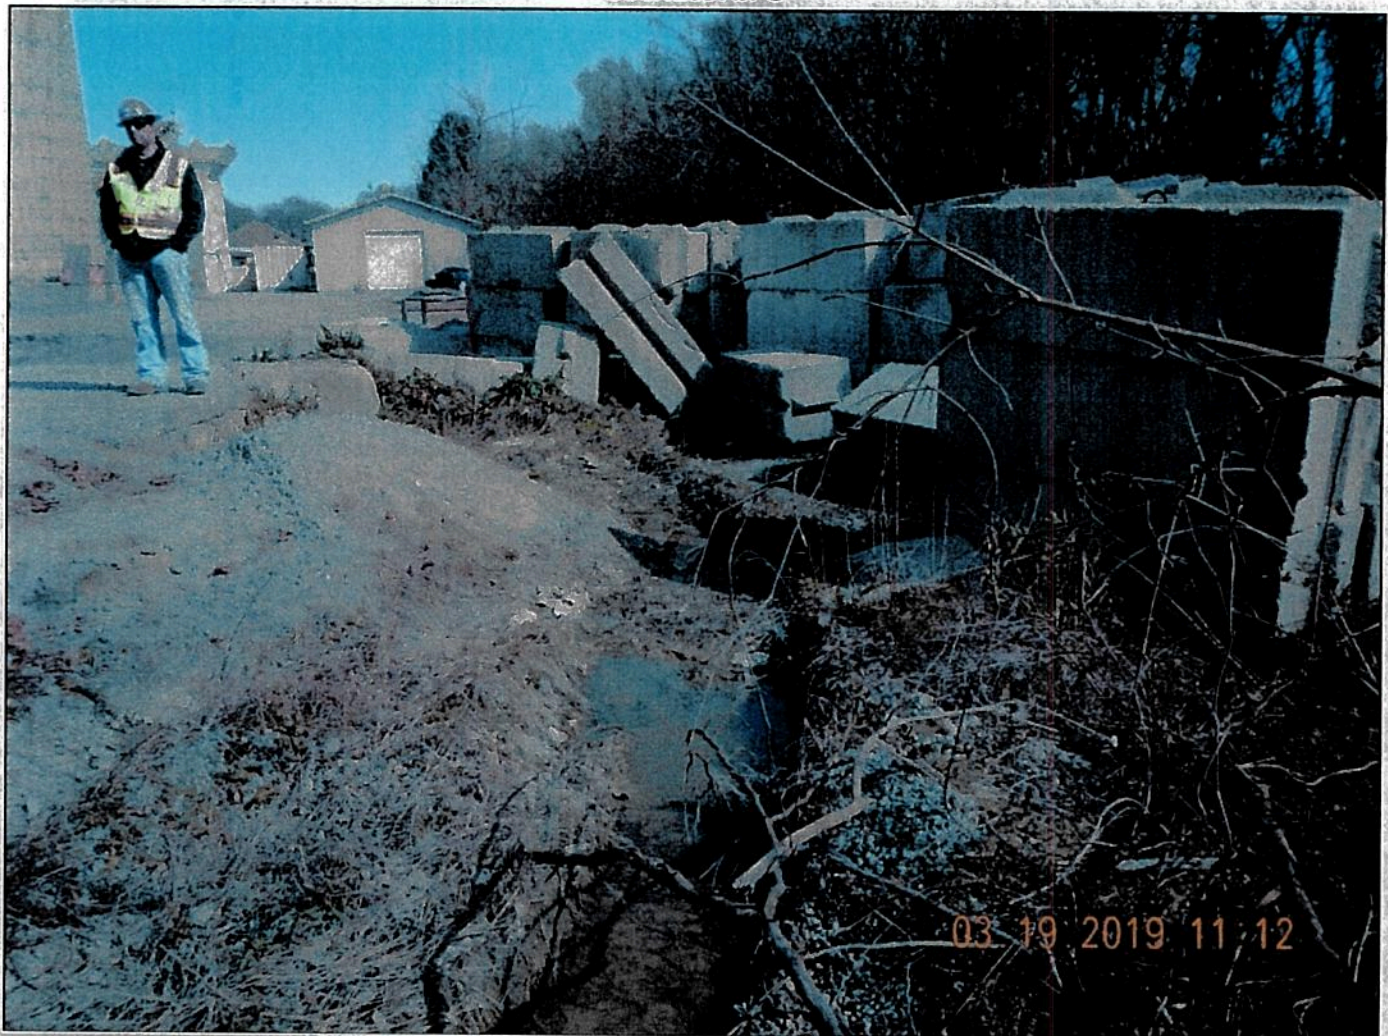
File Name	DSCN1857.JPG
Description	Photograph of the area just down gradient of the removed outfall. The photo shows the concrete blocks used to block off the outfall. The block structure was observed with gaps between the blocks which would still allow for stormwater discharges.
Latitude	N 35° 27' 35.00"
Longitude	W 81° 15' 34.70"

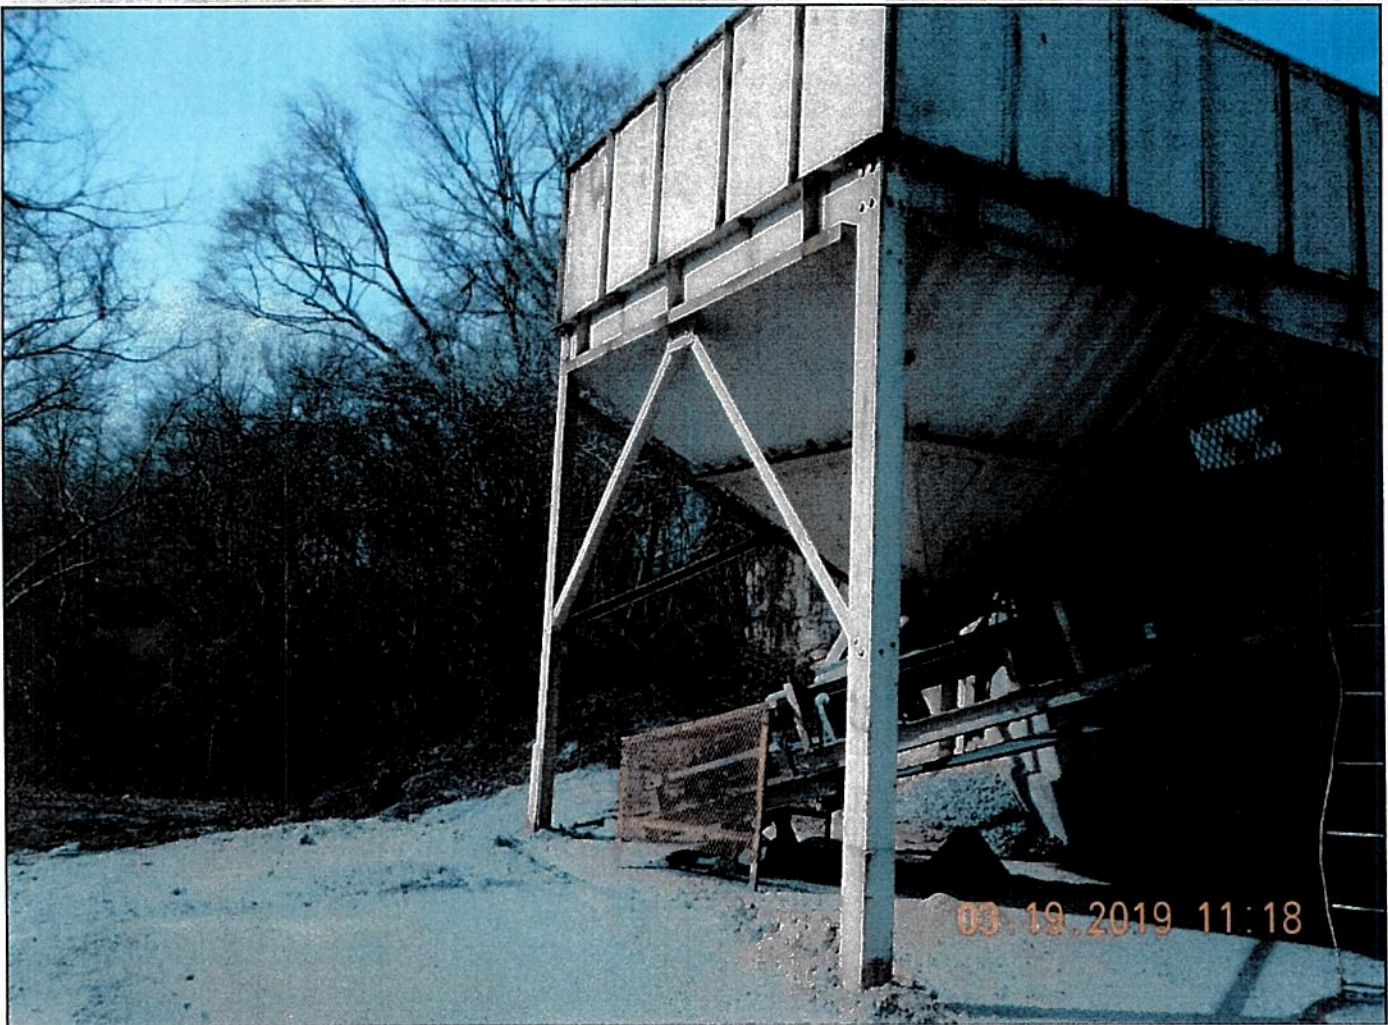
File Name	DSCN1858.JPG
Description	Photograph of the loading hopper to the storage silos. The loading hopper was located near the crest of a hill leading to the stream. Sediment accumulation was observed along the ground in this area which drains towards the stream.
Latitude	N 35° 27' 35.51"
Longitude	W 81° 15' 35.04"

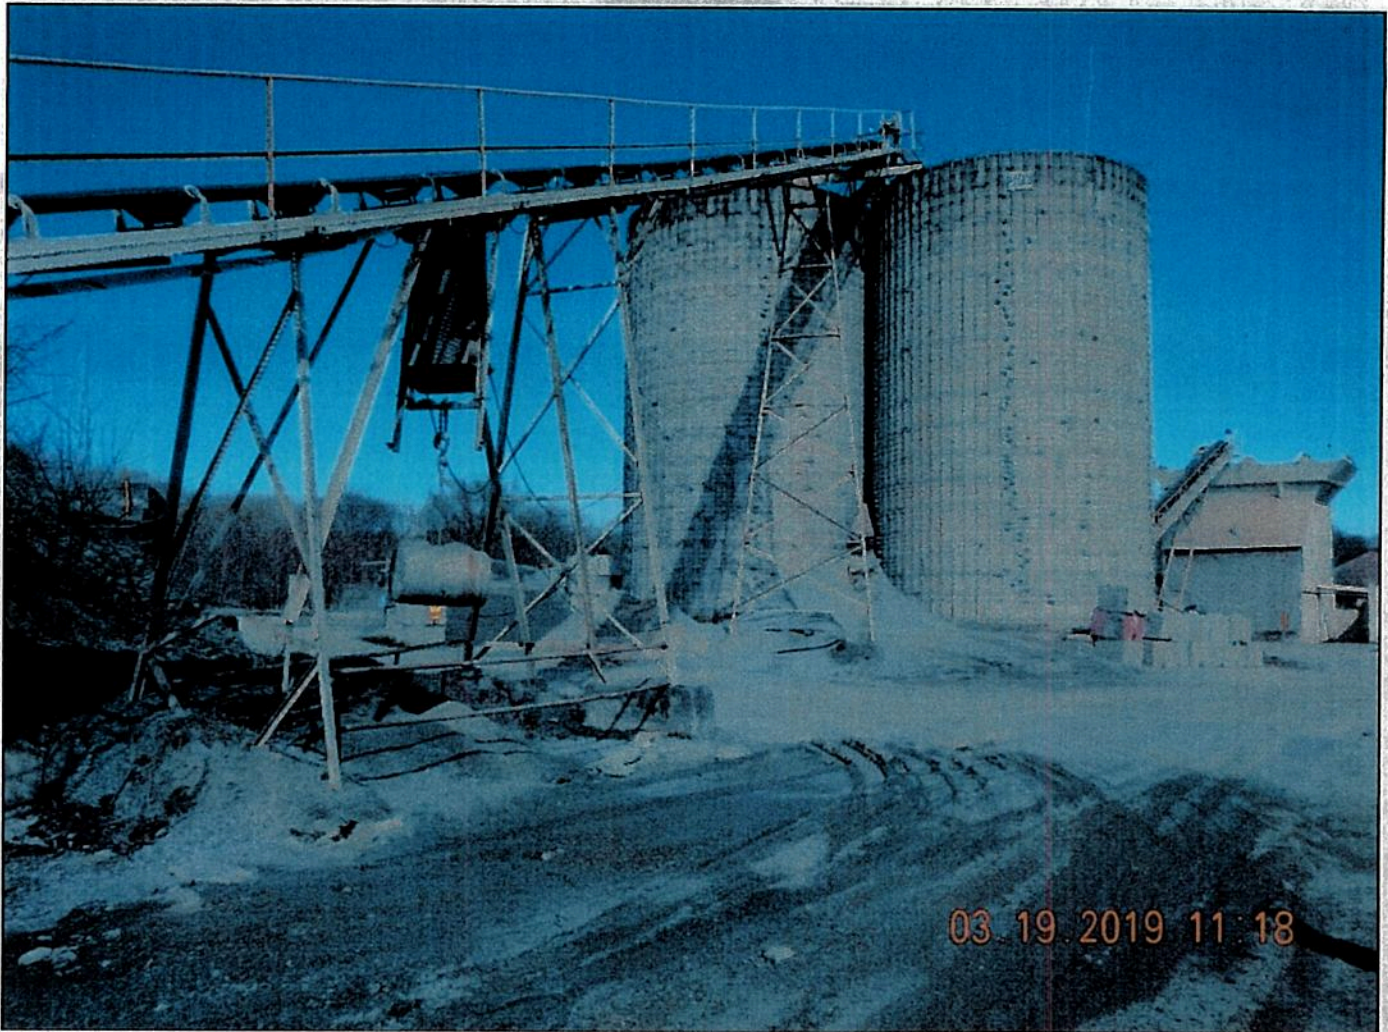
File Name	DSCN1859.JPG
Description	Photograph of the loading conveyor to the storage silos. The loading hopper was located near the crest of a hill leading to the stream. Sediment accumulation was observed along the ground in this area which drains towards the stream.
Latitude	N 35° 27' 35.53"
Longitude	W 81° 15' 35.04"

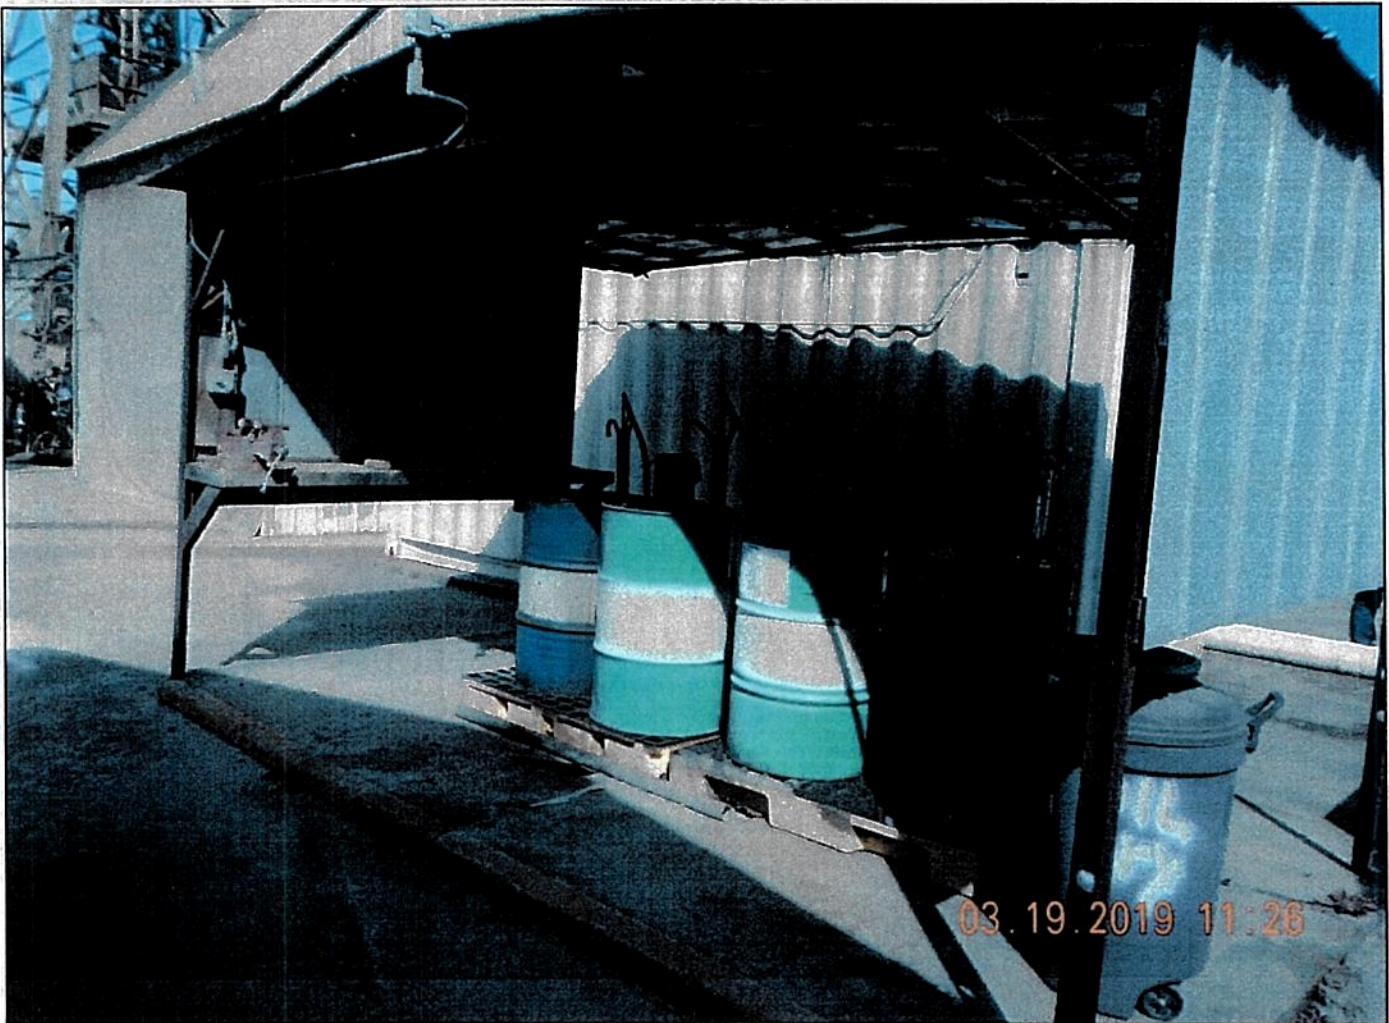
File Name	DSCN1860.JPG
Description	Photograph of the covered area used for oil storage. Oil drums were observed on secondary containment structures and underneath cover.
Latitude	N 35° 27' 37.07"
Longitude	W 81° 15' 35.05"

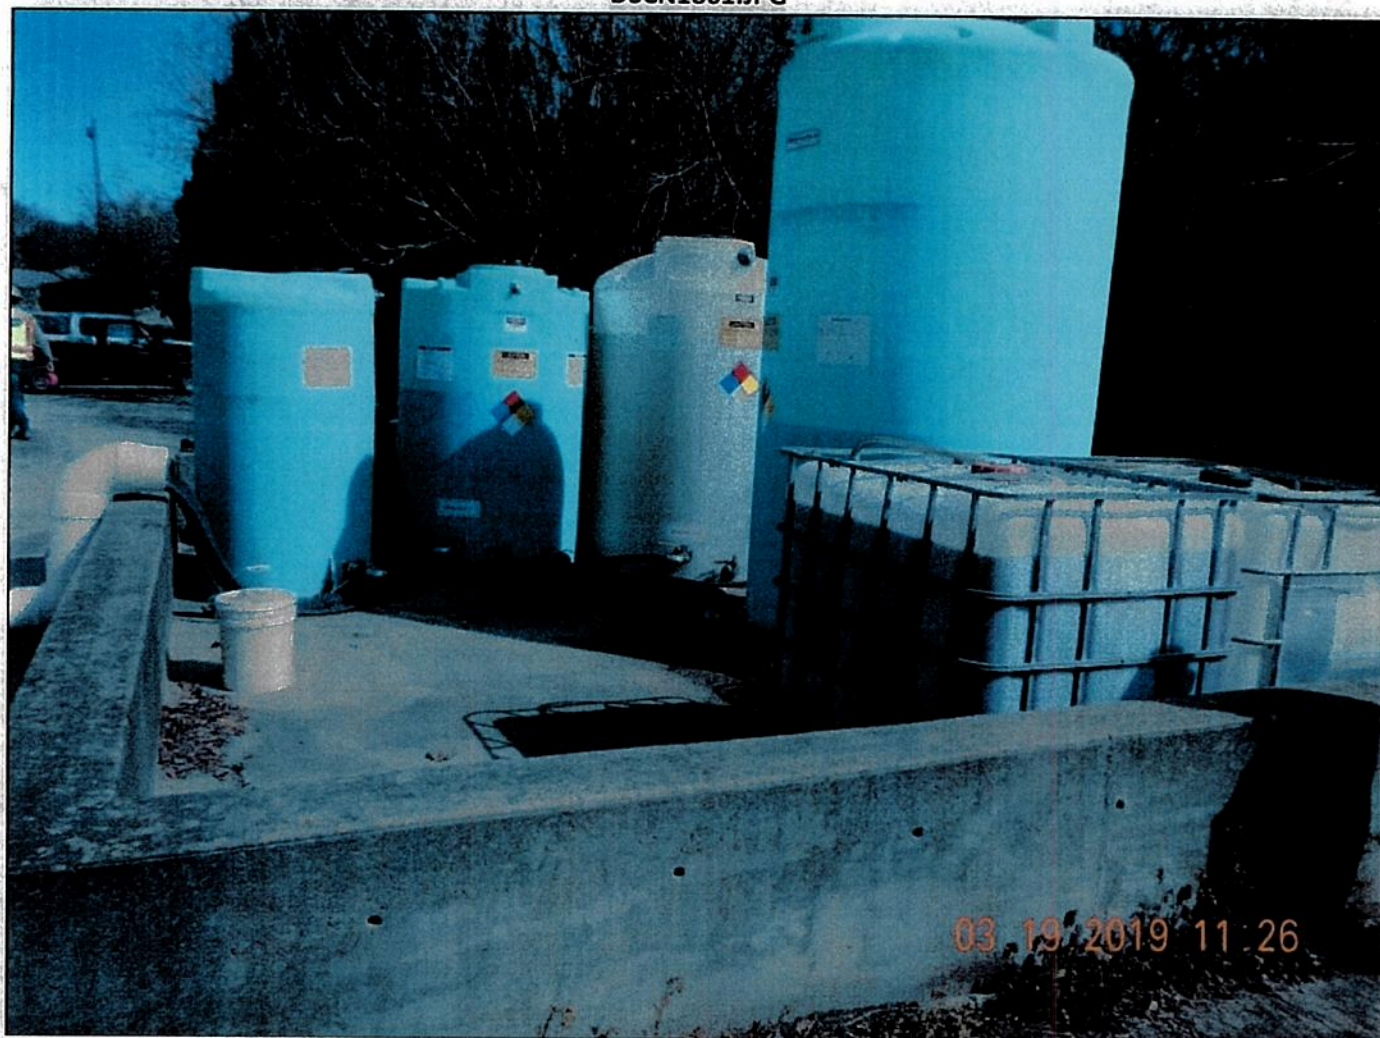
File Name	DSCN1861.JPG
Description	Photograph of the outdoor chemical storage area and tanks. The tank area had a secondary containment structure with a release valve. The valve, which was observed with the valve handle removed, was observed closed during the inspection.
Latitude	N 35° 27' 37.18"
Longitude	W 81° 15' 35.04"

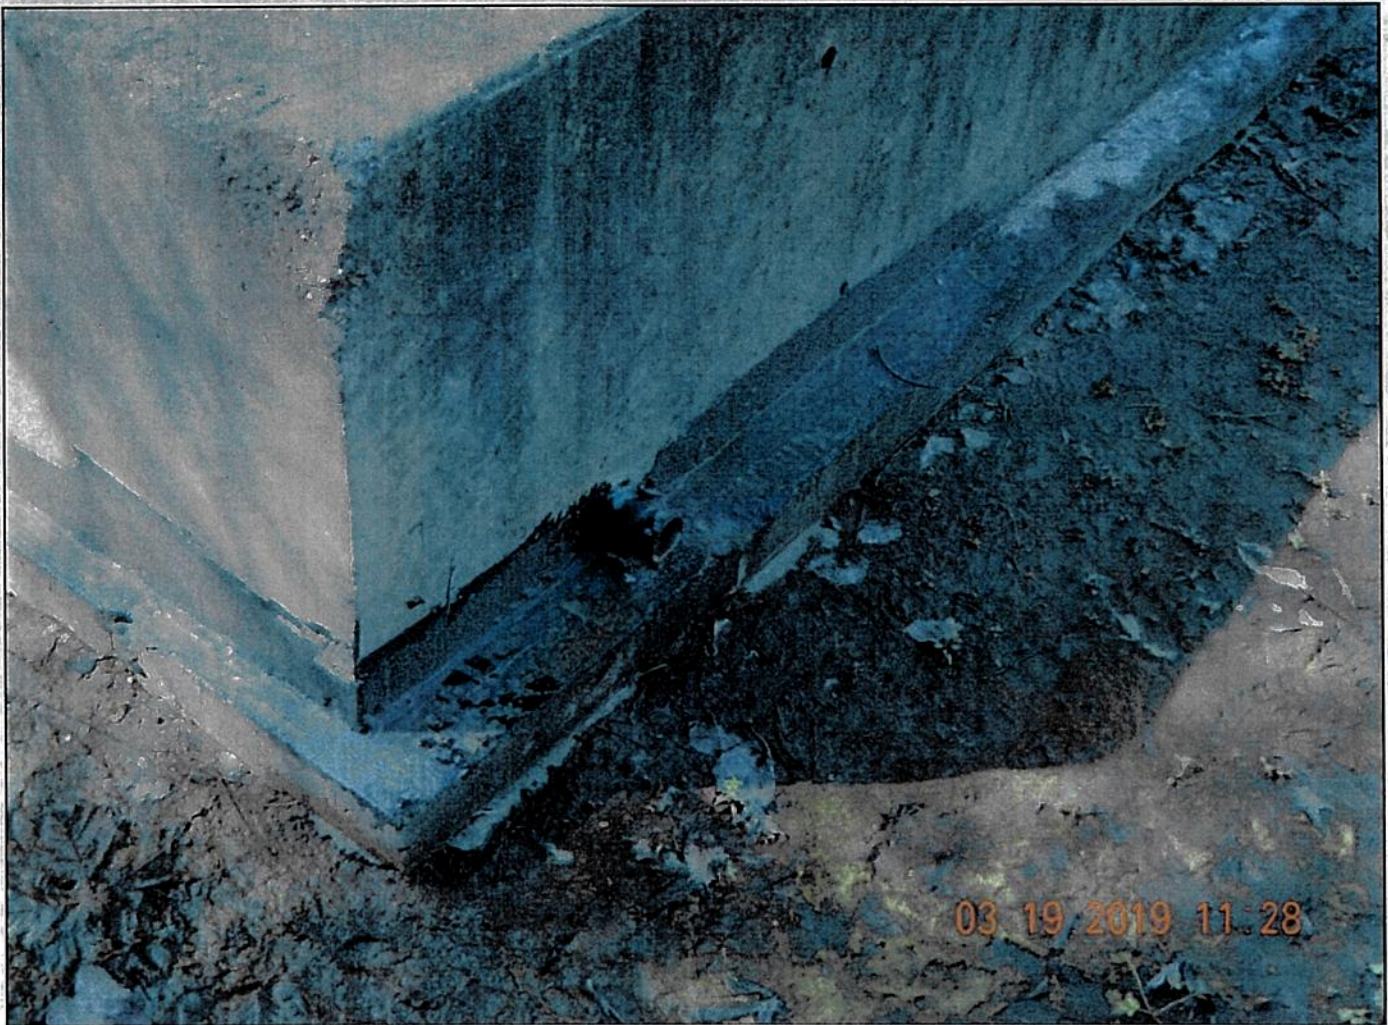
File Name	DSCN1862.JPG
Description	Photograph of the outdoor chemical storage area and tanks. The tank area had a secondary containment structure with a release valve. The valve, which was observed with the valve handle removed, was observed closed during the inspection.
Latitude	N 35° 27' 37.43"
Longitude	W 81° 15' 34.91"

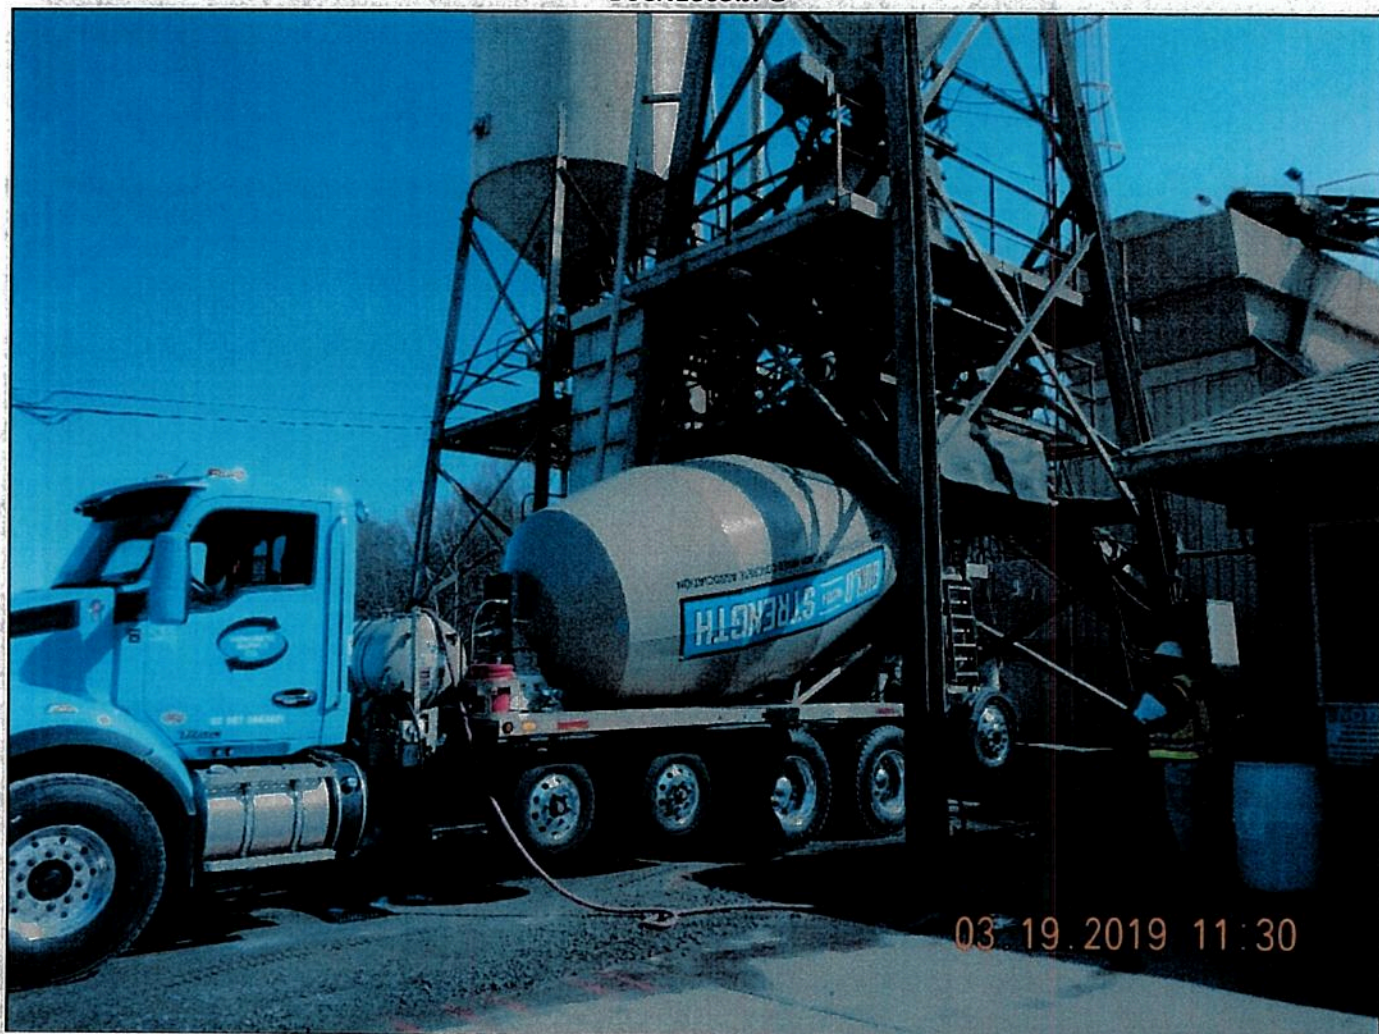
File Name	DSCN1863.JPG
Description	Photograph of the truck loading operation.
Latitude	N 35° 27' 37.07"
Longitude	W 81° 15' 36.27"

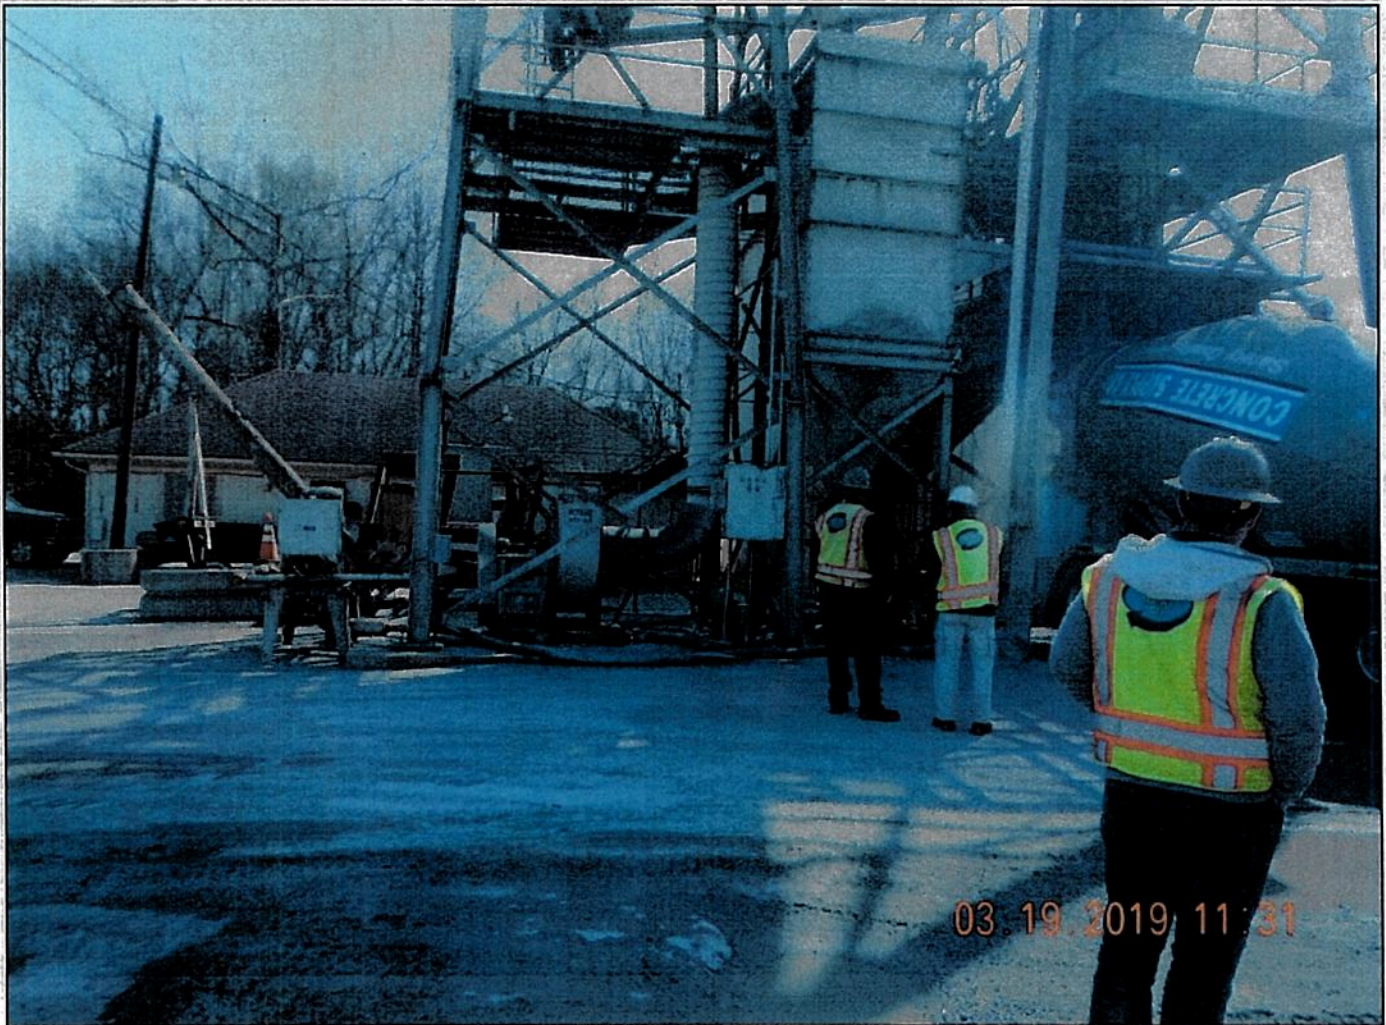
File Name	DSCN1864.JPG
Description	Photograph of the truck loading operation.
Latitude	N 35° 27' 37.76"
Longitude	W 81° 15' 36.42"
